Invicta Arboriculture

Our Ref: IA23/673

You have instructed me to undertake a visual inspection and risk assessment of the mature Beech trees located within the grounds of Crabble Sports Ground, Crabble Road, Dover and to provide an arboricultural report on their structural and physiological condition and to make recommendations for their immediate and/or future management due to concerns you have over their structural integrity.

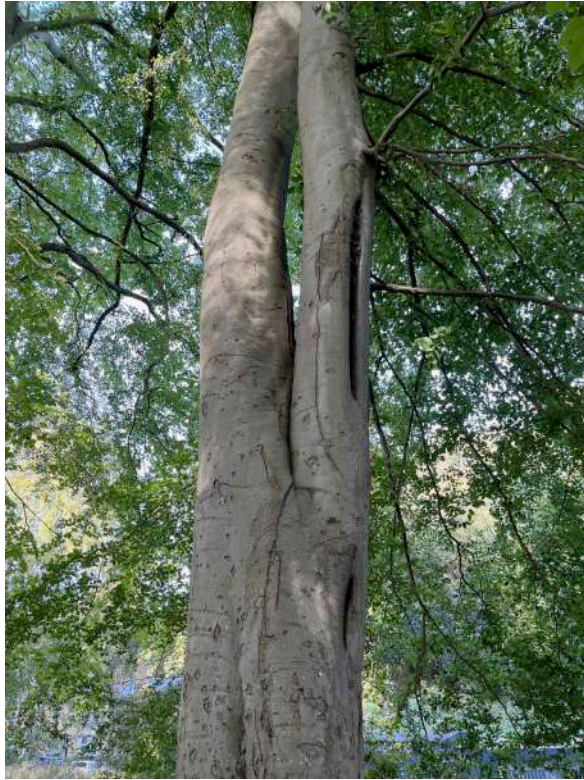
Fungal pathogens aside, a visual inspection of the trees revealed that many of the Beech trees present have observable structural defects such as tight forks, weak unions, un-occluded cavities, pockets of decay and exposed shallow root systems that will in time become compromised and as such are considered to pose an increasing and unacceptable risk to residents, pedestrians, and motorists within Crabble Avenue and those accessing the sports ground via the eastern wooded copse. I include two photographs below showing typical examples of the sub-optimal structural features that many of the trees present display.

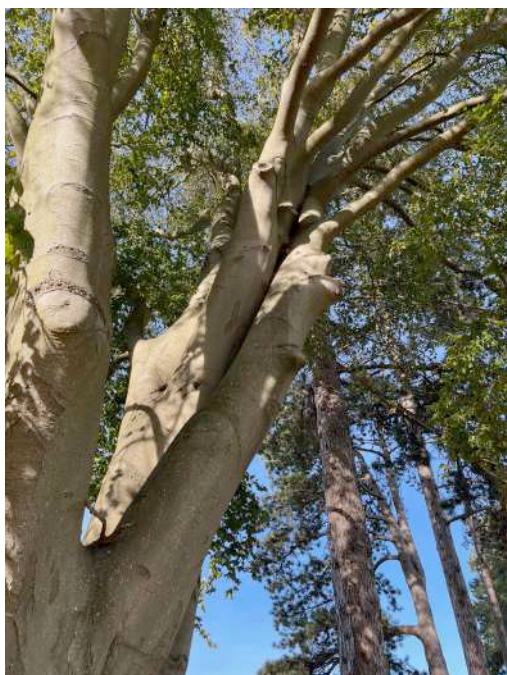
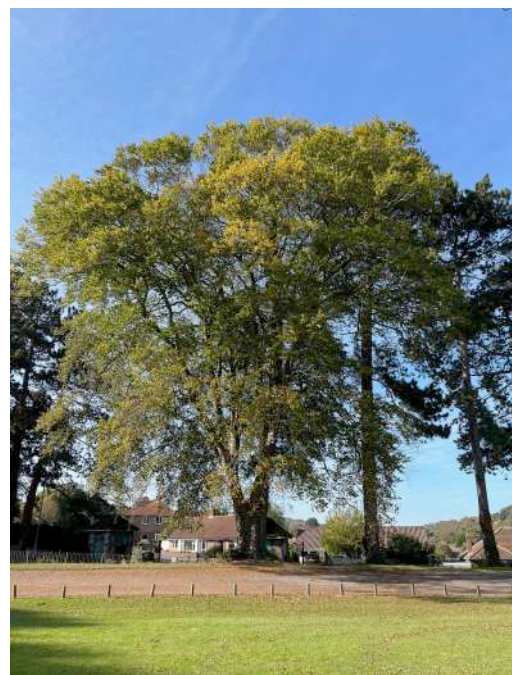
The exception to the above is the single Beech tree that stands at the entrance to Crabble Sports Ground off Crabble Road. This large, fully mature specimen tree stands at twenty-five metres in height with a canopy spread of ten metres to all four cardinal points and supports a full, wide spreading canopy that dominates the western boundary of the site. This tree, like those referred to above also has a number of noticeable structural defects; most notably the tight fork within the base of the large diameter (>300mm) north east facing stem arising at three metres above ground level along with numerous large diameter (>150mm) over-extended branches throughout its canopy. In addition to this there are three immature *Ganoderma spp* fungal fruiting bodies present at the base of the tree on the south-western and eastern sides.

Whilst the presence of the immature decay fungi currently poses no significant risk, it is important to reduce the loading within the trees canopy to safeguard the sub-optimal structures referred to above. A prescription is therefore made for the overall reduction of the height of the tree by four metres and its lateral spread by a maximum of three metres. The Beech at the entrance to the sports ground occupies an extremely exposed position to which it has adapted to over many years. The prescribed works are considered to be in accordance with good arboricultural practice. In addition to the overall reduction of the trees canopy a further recommendation is made for the installation of a non-invasive flexible brace to add

further support to the north-east facing stem. The non-invasive flexible brace should be installed in accordance with Figure D.2 BS3998:2010 and is reproduced below for reference. Bracings with an eight tonne rating are recommended.
