BANKSY'S BREXIT MURAL, DOVER

PRELIMINARY ASSESSMENT OF THE OPTIONS FOR THE
PRESERVATION OF THE MURAL

Preliminary Assessment of the Options for the Preservation of the Mural

Ref. Banksy Dover 1

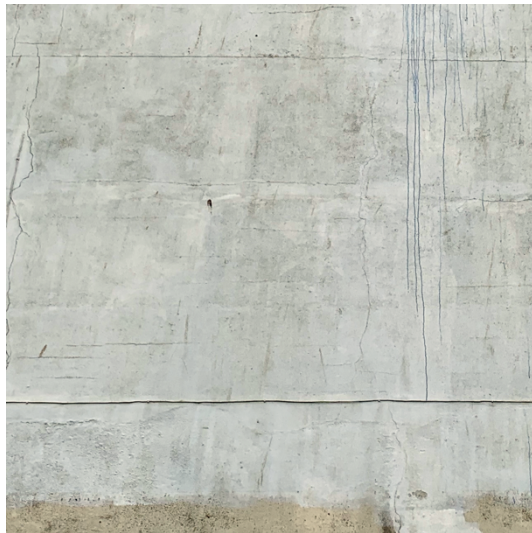
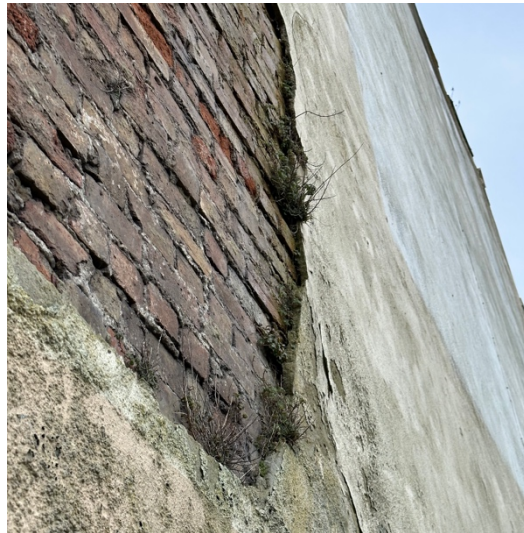
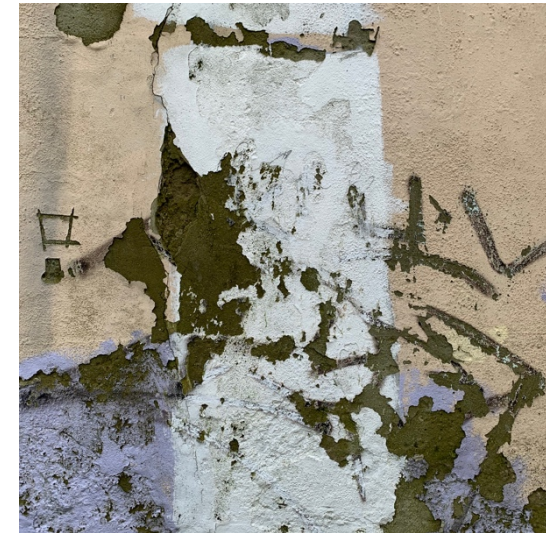
The building arranged over four floors is of substantially brick construction, the courses being a mix of headers and stretchers the wall is likely to be 9 inches thick. Despite the very poor condition of the building as a whole the brick wall support behind the mural appears relatively sound with structural cracks apparently being limited to cracking of the render, some following the courses of brickwork. Structural issues are understood to be primarily associated with the general levels of neglect resulting in instability of the roof and internal structures. The interior of the building is currently inaccessible due to safety concerns and the wall has not been assessed internally.

Overall the cementitious sandy render which forms the support for the mural appears generally well adhered to the brick substrate but some areas of substantial loss are visible towards the rear of the building (*photo centre below*). Viewed from a distance the sandy yellow-tinted render appears to be compact and cohesive in most places at high level but localised areas of disaggregation are evident where the protective paint layer has been lost, particularly at lower levels (*photo lower right*)

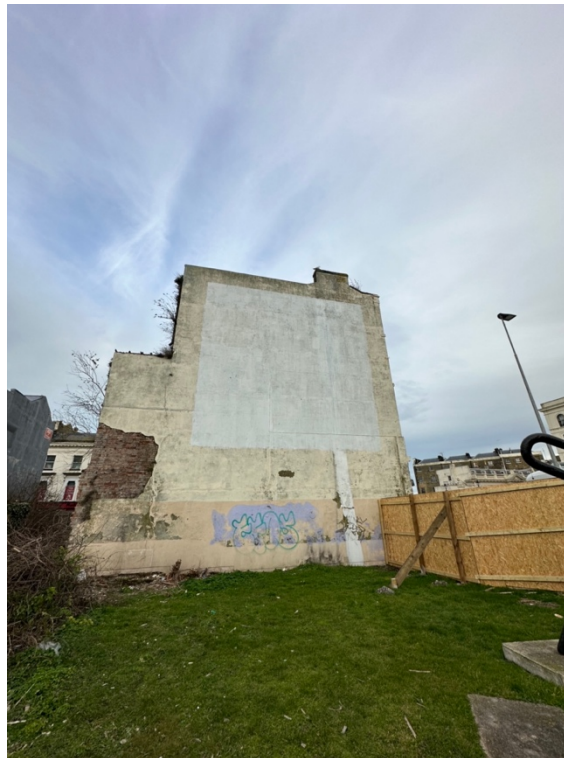
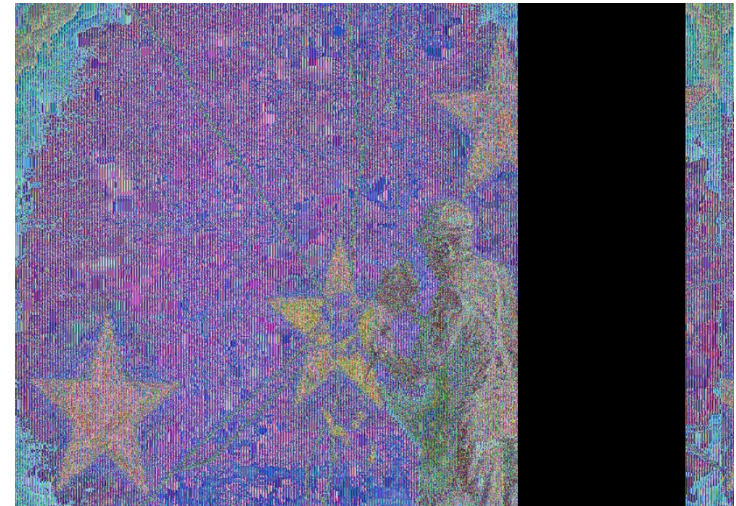
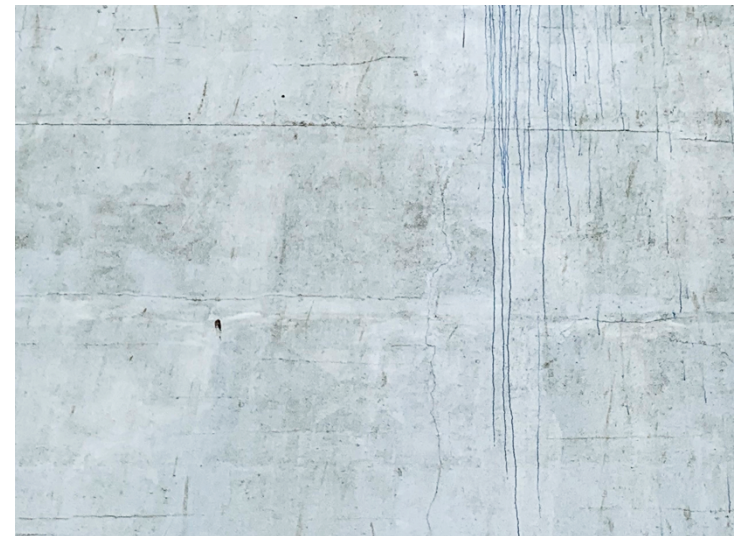
The wall (*photo lower left*) as it appears now following the application of white paint to the mural over the weekend of the 24th and 25th of August 2019. Originally a bright white overpaint the colour of the white has dulled considerably and in parts looks to have thinned sufficiently, due to weathering, that elements of the mural are visible through the layer. The level of thinning is uncertain and this may be misleading, however, as the wall has also become dirtier as algae and other materials have either been deposited or grown on the surface. Compare the workman and stars in the image top right to the same area today (*photo lower right*) where some of the star design is evident under the white.

The image produced by Banksy is a composite of different paint types and application techniques all of which will have an influence on the techniques required to remove the overpaint. The blue background would probably have been applied by roller and is likely to have been an exterior masonry paint chosen for its longevity outdoors. The stars are executed using a stencil as can be seen in their slightly uneven application. The figure of the workman and the ladder are likely to be spray painted using stencils for the main elements combined with free hand spray painting for areas such as the shadows. The cracks radiating from the broken star are likely to be freehand brush work. Prior to the application of the overpaint it is though the mural had survived in good condition.

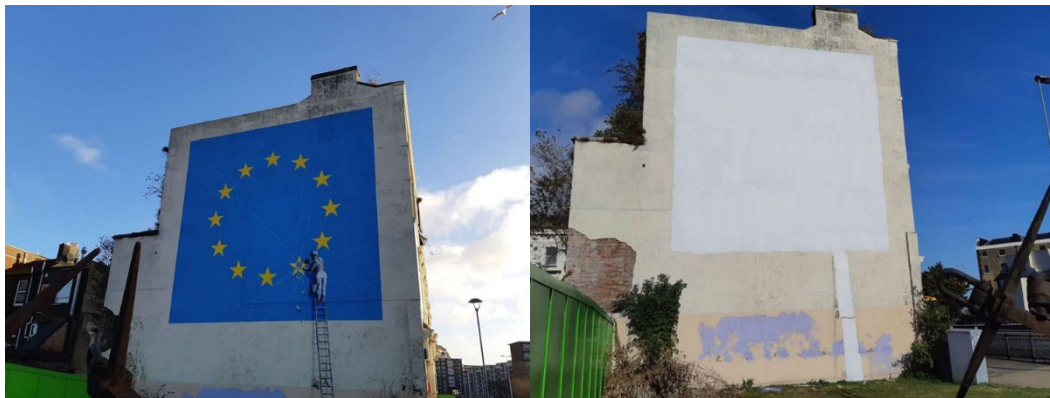
Banksy mural before and after covering up.
