# Nelson Street Conservation Area Appraisal

January 2017

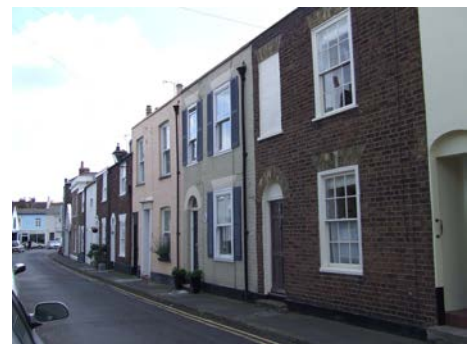
A typical terrace with coherence but differences  
in detailing (Water Street)

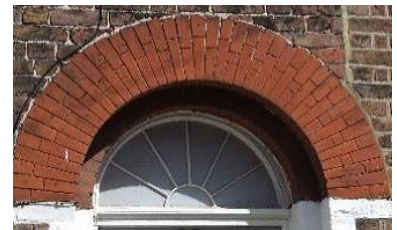
Typical features above a doorway

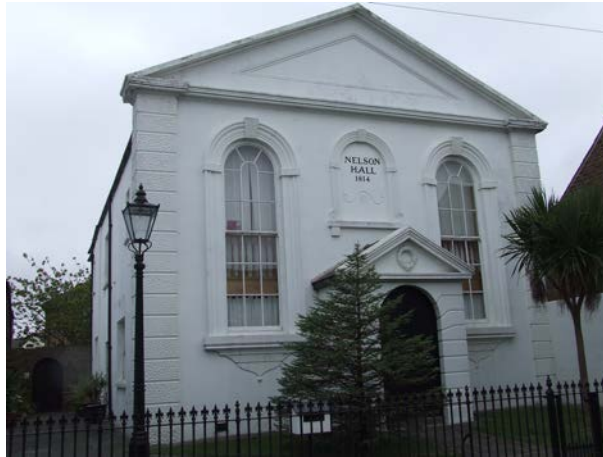
Nelson Street was largely constructed between 1811 and 1835. The Nelson Chapel was built in 1814 and is now a grade II listed domestic residence. A bungalow was built in 1909. With two exceptions the houses are built to the pavement and that is what defines the space. The houses are predominantly two storeys with a small number of two storeys with basement. The main construction material is brick which in a significant number of cases has been painted. A small number have been rendered. The majority of the houses have slate roofs although the earliest buildings, constructed between 1811 and 1814 have Kent peg roofs. Valley gully's and shared downpipes are a feature of the roofscape.

Nelson Chapel (Grade II Listed)

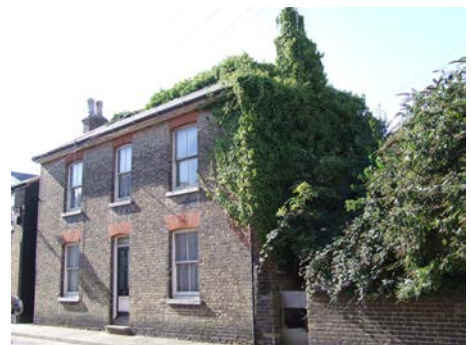
Some properties had undergone alterations with an additional storey being added. The whole street consists of domestic residences, including the Nelson Chapel. Historically there is evidence of properties being built to let and this usage appears to continue. One property was in a state of serious disrepair.

37 Nelson Street, in a state of disrepair at the time of the appraisal

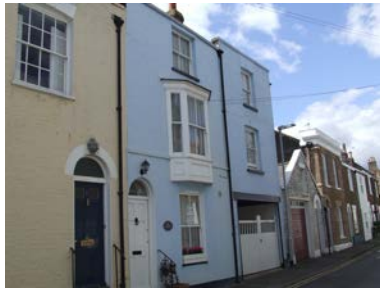
Variation in building styles

The houses are all built of bricks. There is a small amount of render, Artex and pebbledash and in a number of cases the brick has been painted. The roofs are a mixture of slates and Kent peg tiles. On the north side of the street the chimney stacks are imposing and create a dominant note in the street. There was one dominant pediment which seemed over heavy for the house's facade.

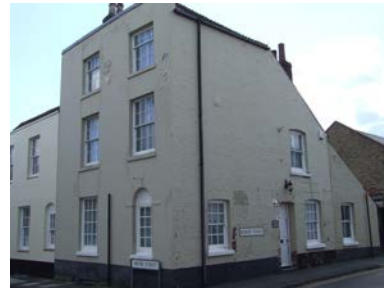
two storeys with basements, steps leading to the front entrance door and curved boundary walls between each property. Although there is considerable variety in architectural style the street has continuity and coherence. One building (Duke House) is Grade II listed.

Duke House (Grade II listed)

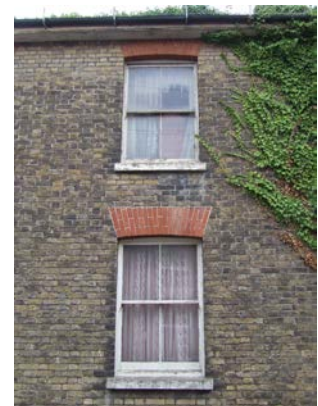
Soldier arch of typical style for this area

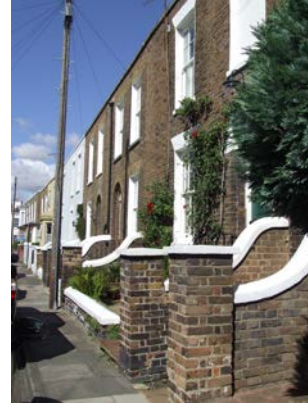
The small spaces in front of the houses at the lower north side extend the sense of space in the street. The steps up to the front doors, the curving walls leading down to gate pillars and the small spaces in front of the houses all contribute to that sense of space. A small courtyard to the south of the street also creates a pleasing interlude. The pavements are largely paving slabs but some use of tarmac was noted. There were four modern streetlights and one traditional one. The telegraph posts and wires appeared intrusive and there were a number of redundant metal signposts. There is parking down one side of the road but traffic seemed to be very low. Overall the street had a quiet domestic character.

Steps up to the houses on the northern side

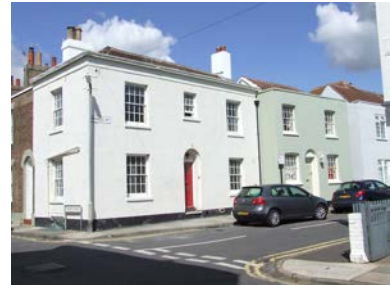
Sydney House (1) and Yewdale (3), Princes Street (each Grade II listed)

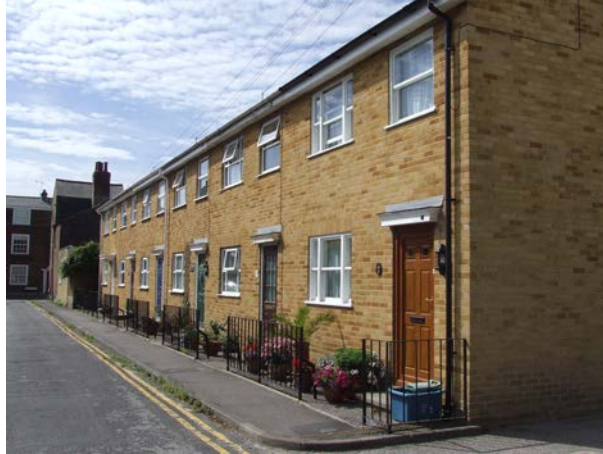
Terrace built in 1977

The overall effect lacks continuity. The size and scale of the properties is appropriate to the street. Most are brick built but with some use of render and pebbledash. The row of modern houses on the west side replaced a large house which had been the Bell Inn. A property on the east side was the Alhambra Music Hall historically and a property on the corner of Robert Street and Water Street had been the Duke of Wellington public house; all the properties are now domestic residences.

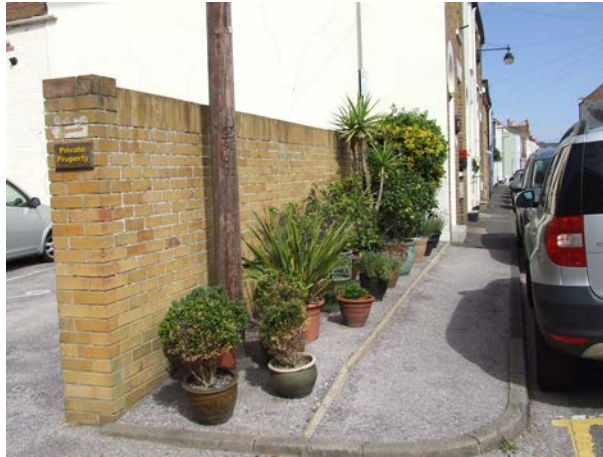
A small car park to the west of the street and a large vista with gardens outside the conservation area creates a good sense of space in the middle of the street. The railings to the front of the modern terrace, often enclosing flower pots and shrubs, also added to the sense of space. With only a small number of the houses built up to the pavement this creates a very different sense of space to some of the other streets in the area. The use of tarmac for the pavement surfaces, a very patchy road

Pots adding to the feeling of space

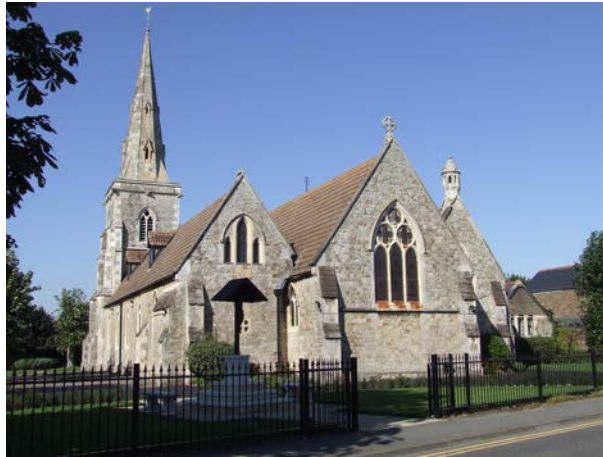
St Andrew's Church (Grade II listed)

Following the demolition of the late Eighteenth Century Deal Workhouse, St. Andrew's Church was built 1848-1850 and consecrated in 1850, it is Grade II listed. The church, built of Caen stone, was a response to the economic depression that affected Deal after the Napoleonic wars and the increasing poverty among the boatmen of Deal. It is still popularly known as "The Boatmen's Church". The church is a prominent and dominant feature on the western side of the conservation area. The building suffered from some Second World War damage; earlier photographs show a slate roof but it is now tiled. A window to the back of the church has been filled with flint stones. The west boundary wall to St Andrew's Church is shown on the tithe map and is possibly related to the Workhouse.

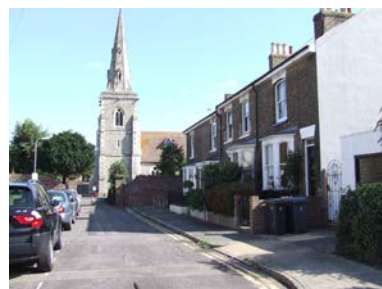
A small portion of St. Andrew's Road immediately adjacent to the church gates falls within the conservation area boundary. The houses, which vary from a late 18<sup>th</sup> century cottage to small terraces built in the 1880's are largely brick built. Some of the brick has been painted. There were five of the ten houses with uPVC windows varying in quality and design. The doors are also diverse. The condition of the houses varied considerably especially on the west side of the road.

St Andrew's Road

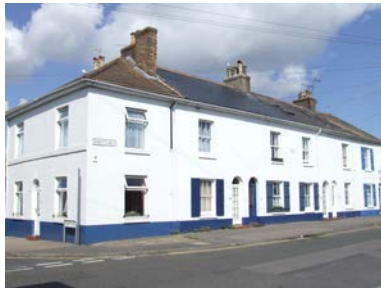
The buildings in West Street that fall within the conservation area boundary are varied. On the west side of the street there is Stafford Terrace, probably mid 19<sup>th</sup> century, a small commercial building and a small Victorian cottage. On the east side there is a range of small cottages from the late 18<sup>th</sup> and early 19<sup>th</sup> century, a number of small early 19<sup>th</sup> century cottages hidden behind high garden walls, a pair of 1980s houses and a very substantial commercial building which probably dates from the late 18<sup>th</sup> century. Some of the properties, especially Stafford Terrace, have been rendered but the dominant material is brick.

Stafford Terrace, West Street

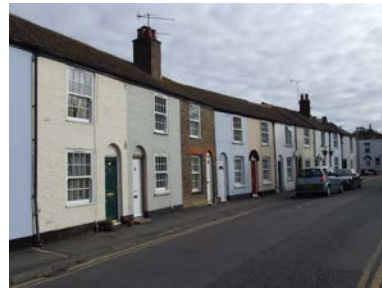
Row of cottages on the east side of West Street

In total there were 16 of the 24 properties with uPVC windows varying in quality and design. 99-109 (odd numbers) West Street has a gently curving roofline with a continuous Kent peg tile roof which is particularly pleasing. The windows in the large commercial building at the north-west boundary of the area have all been replaced with uPVC type.

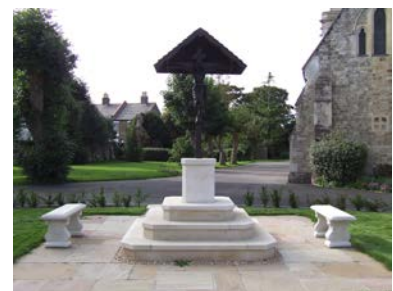
The gardens surrounding St Andrew's Church create a very pleasing formal space in a conservation area that has few open spaces. There are also a higher percentage of gaps between buildings in this part of the conservation area in marked contrast to the houses built up to the pavement in other parts. The new railings, Calgary and seats that have been installed to the eastern frontage of the church grounds in 2014-15 are a major enhancement of the conservation area.

St Andrew's Churchyard and Calgary

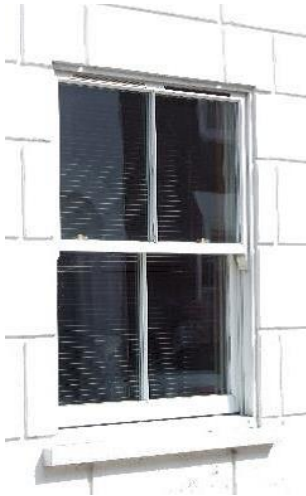
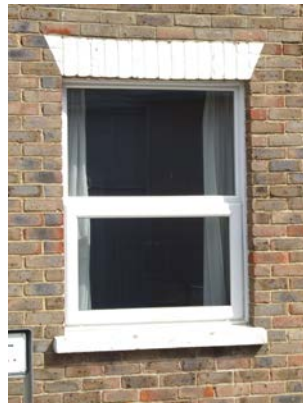
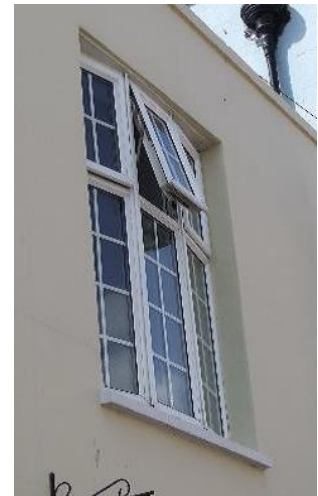
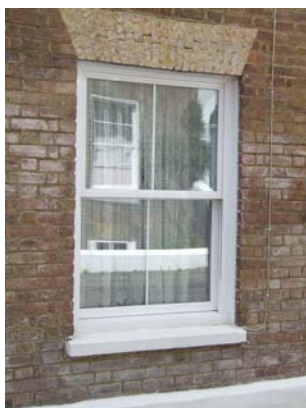
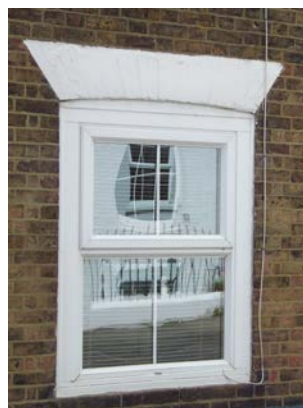
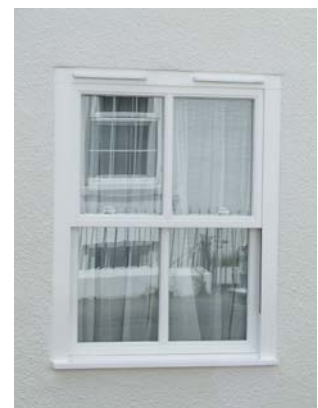
- b. There are a number of buildings that are not listed but are of some architectural or historic interest.
- c. The lack of planning control over the replacement of windows and doors was very evident. The very high number of uPVC windows is a matter of concern. In some cases the windows had been replaced in a sympathetic manner but there were a significant number of replacements where the style was completely alien to the historic character of the property. This also applied to a lesser degree to the replacement of doors.

Double glazed windows of differing levels of sympathy to the area

It is recommended that an Article 4(1) direction be implemented for the whole of this conservation area.

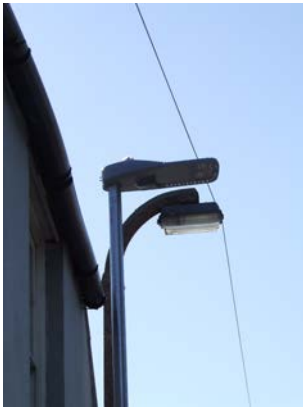
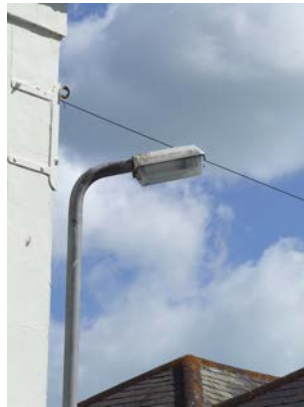
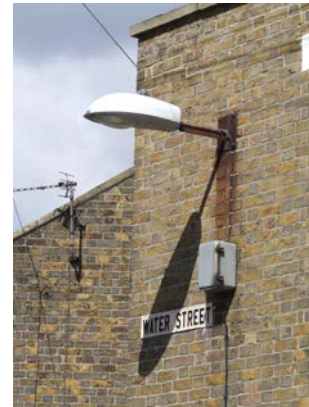
Modern street lights of various styles

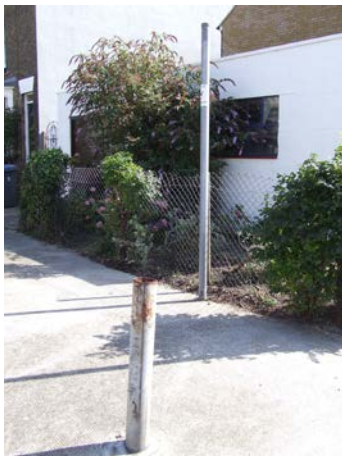
- f. A significant number of disused signposts did nothing to enhance the character of the area. On the corner of St. Andrew's Road and Union Road a metal bollard, in very poor condition, was a visual eyesore.
- g. The pavements and roads were reasonably maintained although some residents would dispute this view. The exception was West Street where the use of tarmac diminished the character of the conservation area. This equally applied to small areas of pavement where paving slabs had been lifted and replaced with tarmac.

Redundant bollard and signpost

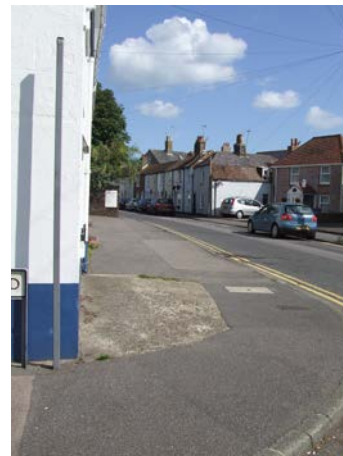
The pavements in these streets were fairly well maintained paving slabs with the exception of West Street where tarmac had been laid over extensive areas of pavement. This did little to improve the appearance of a conservation area. The roads were reasonably well maintained.

Pavement tarmacked in West Street

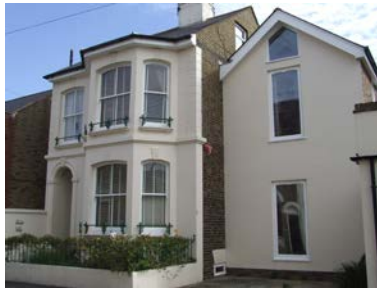
Faber Villa

- Faber Villa, Robert Street – The building is of significant architectural and historical interest.

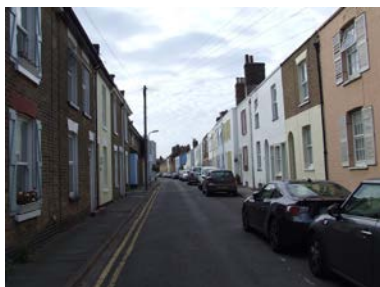
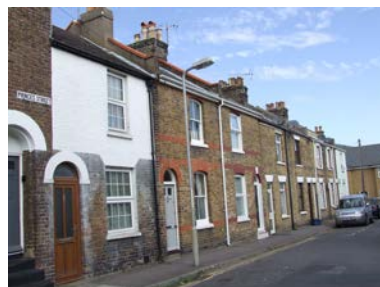
Left photo shows buildings currently in the conservation area, those in the right photo are currently outside it

- The remaining area in Princes Street to the junction with Ark Lane – The similarity in style to the rest of the street argues for its inclusion.
