BANKSY'S BREXIT MURAL, DOVER

PRELIMINARY ASSESSMENT OF THE OPTIONS FOR THE
PRESERVATION OF THE MURAL

Preliminary Assessment of the Options for the Preservation of the Mural

Ref. Banksy Dover 1

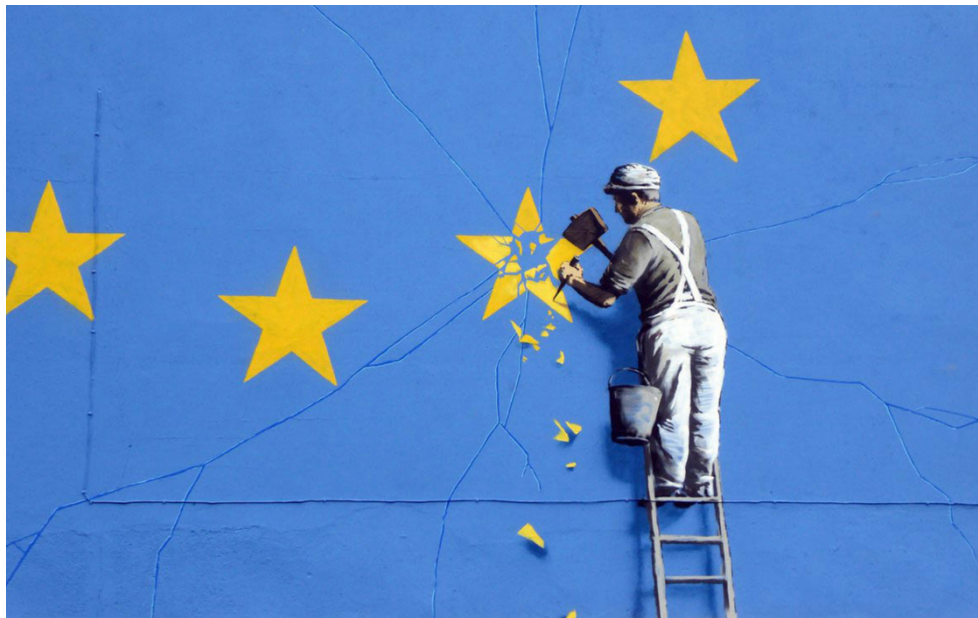
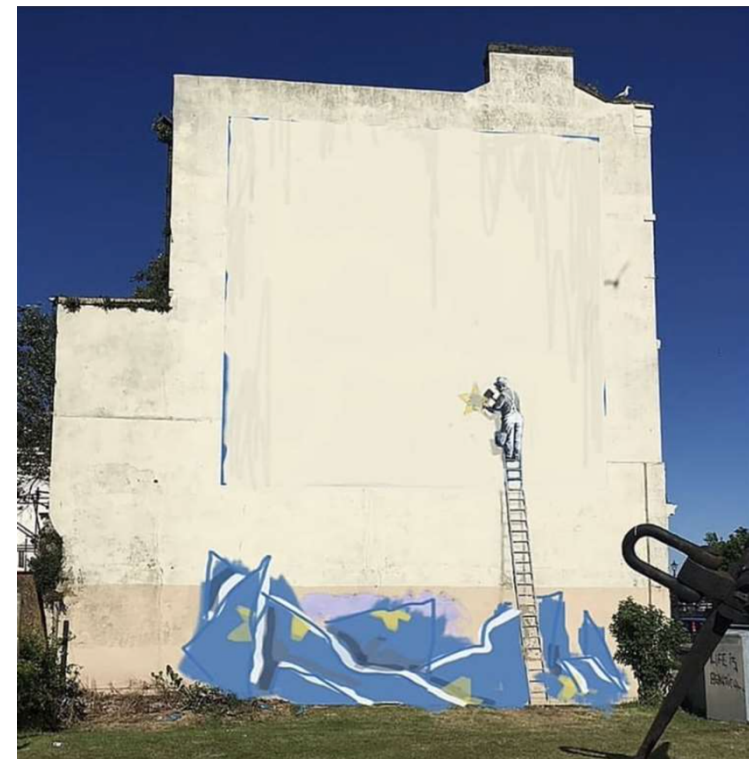
Photos as originally painted and as the artist envisaged it post-Brexit (right): Banksy

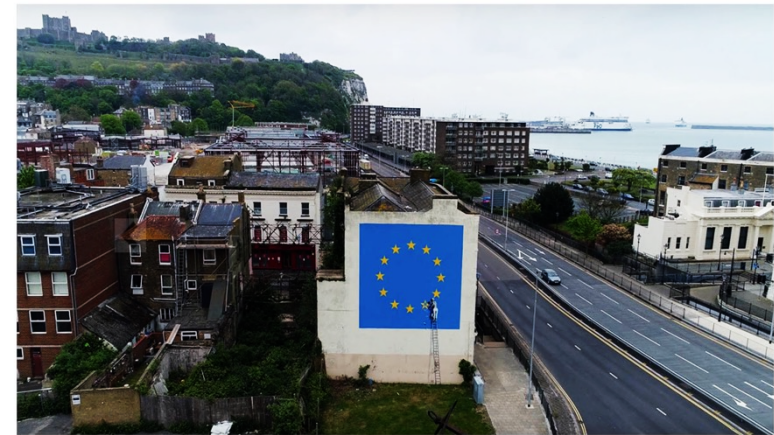
Measurements – The wall itself is approximately 12m high x 9m wide at the upper levels. The blue EU flag measures approx. 7m x 7m with the stars occupying a circle approx. 5m across. The life-size figure of the workman stands on a ladder roughly 4.5m from the ground. The area painted by the artist covers an area measuring approx. 55m².

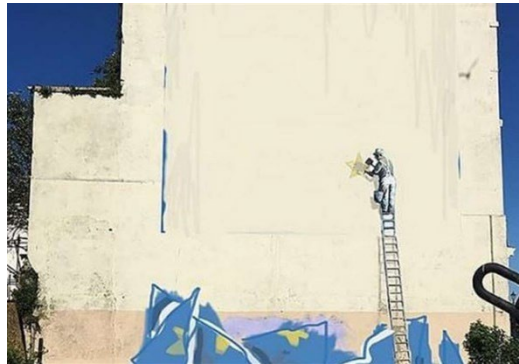
It is known that Banksy himself did not consider the mural to be permanent because he himself had intended to repaint the wall himself following the Brexit decision. He posted the intended replacement design below on his web site and commenting that the 'white flag' (the overpainting) conveyed the same message:
